Investigation report for roughness changes after HOKKAIDO IBURI earthquake Japan, by using Smartphone roughness measurement

YAGI, Koichi BumpRecorder Co., Ltd.

RPUG-PDRG 1st Joint Meeting

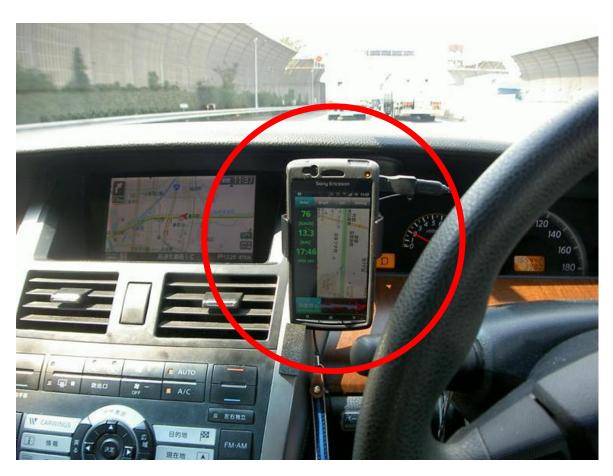
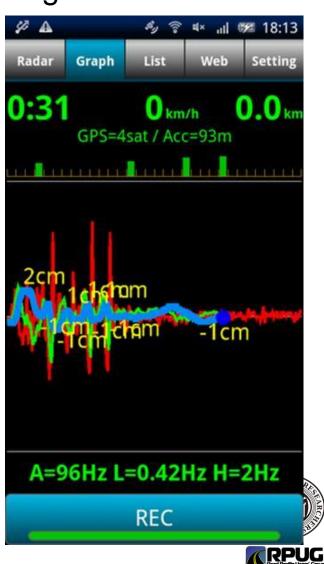
Smartphone type measurement

Vibration data is collected under driving situations.

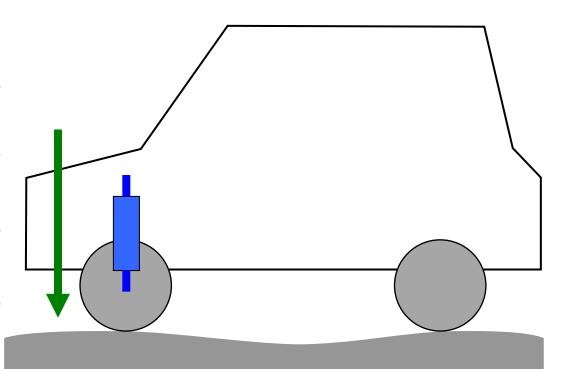
IRI Class 2 calculation process

Measure acceleration (a)

Suspension estimation (b)

Inverted QC simulation (c)

Calculate profile (d)

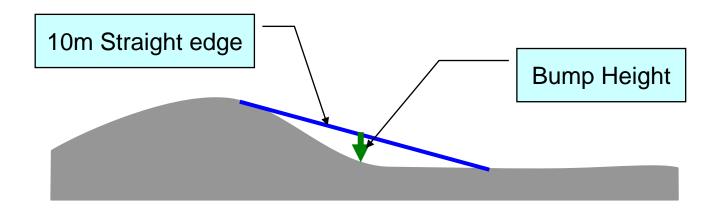
BBI - Boeing Bump Index

Pointed information of the bump size and location.

10m straight edge is used, and deepest depth is defined Bump Height.

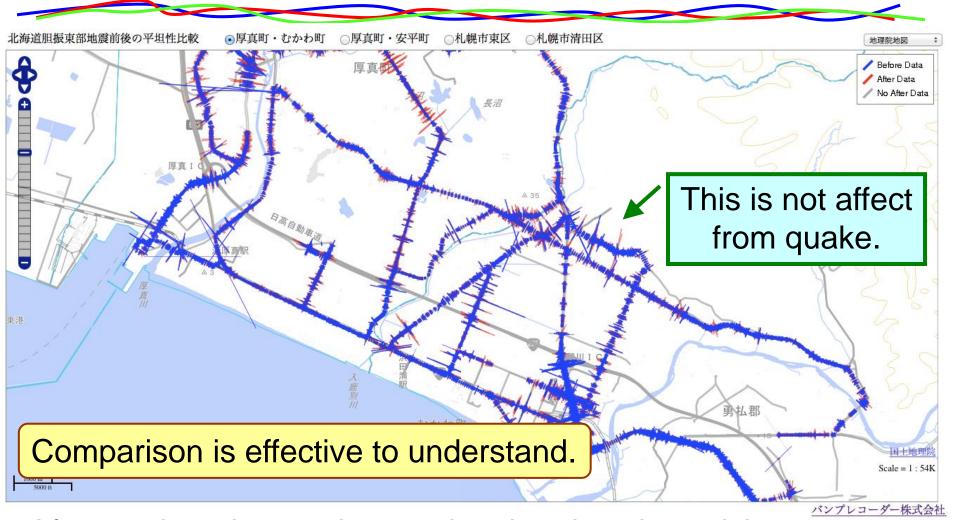
Result before and after 2018

After earthquake roughness situation draw by red line. Before earthquake draw by blue line.

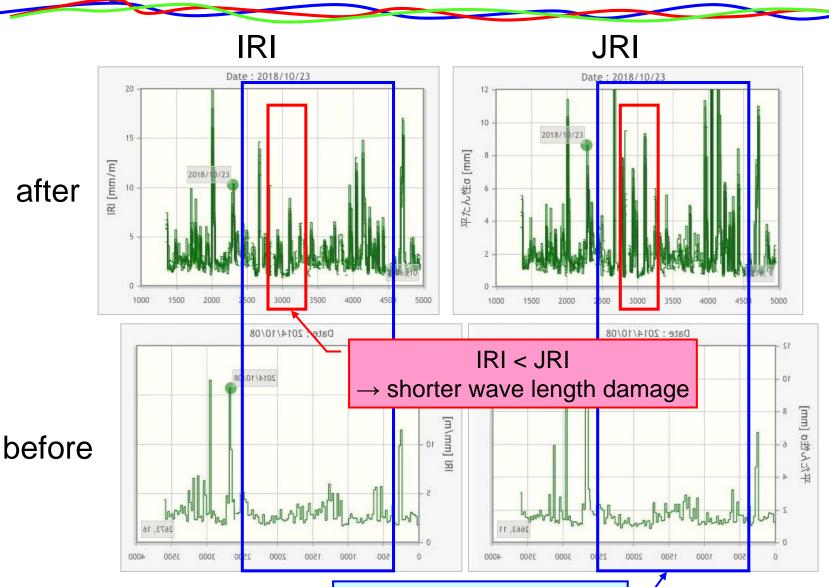
Comparison IRI and JRI

before < after → damage
